Climate Change Impacts on Heritage Timber Structures

Mohammad Kherais (DXR2QS)

Breuer Marcell Doctoral School

University of Pécs

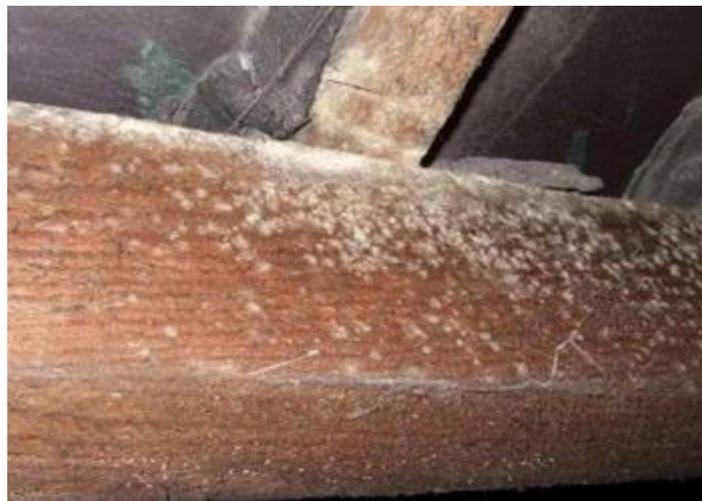
Figure 1. Fungai decay on timber column [The Constructor, 2021]

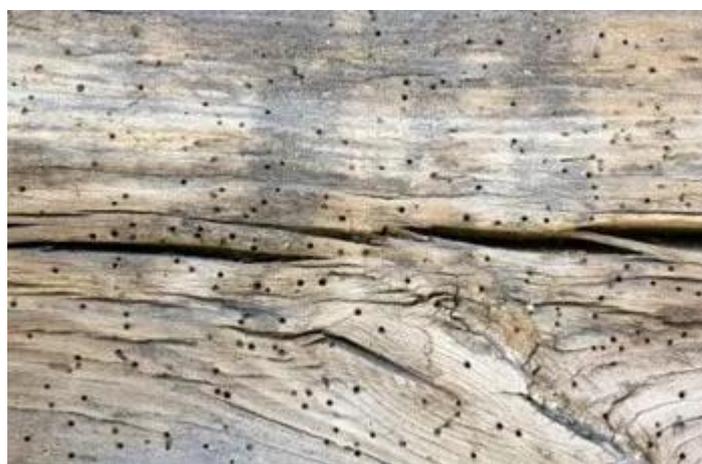
Figure 2. Beetles defects in timber [The Constructor, 2021]

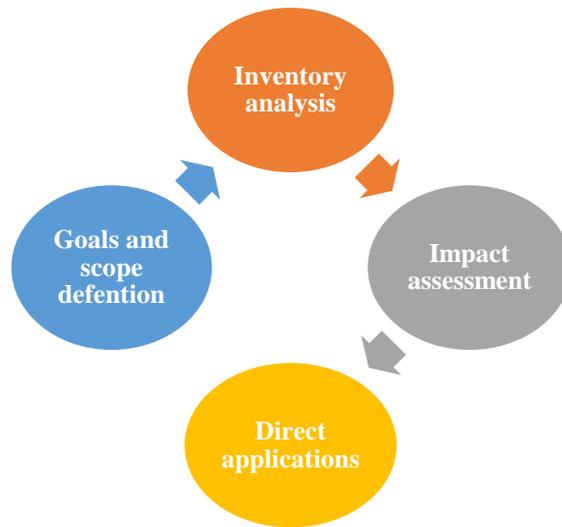
al., 2014, Quintana-Gallardo et al., 2020]. It provides a comprehensive analysis of the environmental impacts associated with different stages of a building's life cycle, including production, construction, operation, maintenance, and end-of-life [Buyle et al., 2013, Cabeza et al., 2014, Quintana-Gallardo et al., 2020, Roh et al., 2018]. The LCA process comprises four stages, as it is presented in Figure 7.

Figure 7. Life cycle assessment framework

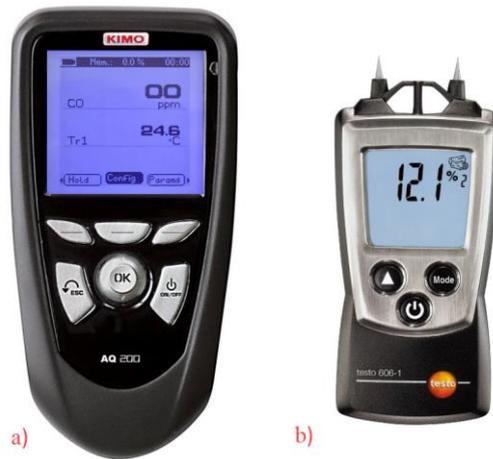
Subsequently, in this phase, temperature (T), relative humidity (RH), and moisture content were quantified employing specialized instrumentation. Temperature and relative humidity were ascertained using the Kimo AQ200 device (see Figure 12 (a)), while moisture content was determined utilizing the Testo 606-1 (see Figure 12 (b)) apparatus. The data collection process encompassed all four seasons for both study sites and was executed via a regimen of daily or weekly site visits (depending on opening hours and, affected by COVID-19 closures). Notably, these measurements were conducted exclusively on the surface of the wood, as invasive or destructive measurement techniques were not permissible for this investigation.

Figure 12. a) Kimo AQ200 b) Testo 606-1

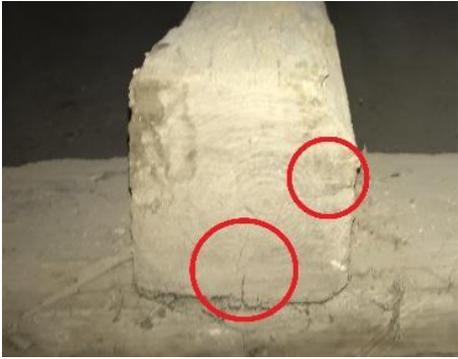
Defect type	Description	Formation reason	Photo	Affected elements
Ring shakes	Longitudinal separation of wood fibres in the tangential direction	Wood ageing, and site conditions

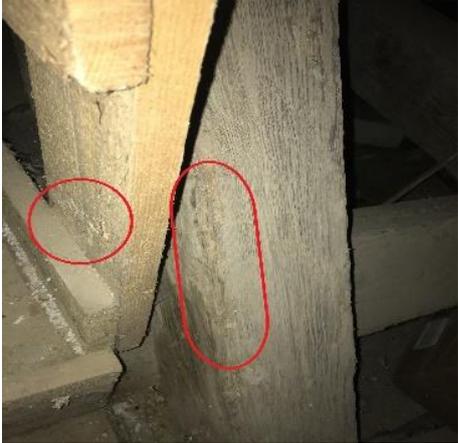
Mainly tie beams and some purlins
Surface peeling	Loss of the wood fibres along the element, few mm from the surface	Constant change of MC and site conditions

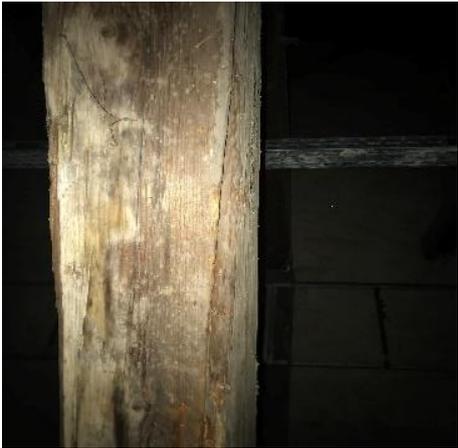
Posts and struts
Surface whitening	Tendency of the surface colour to white	High MC

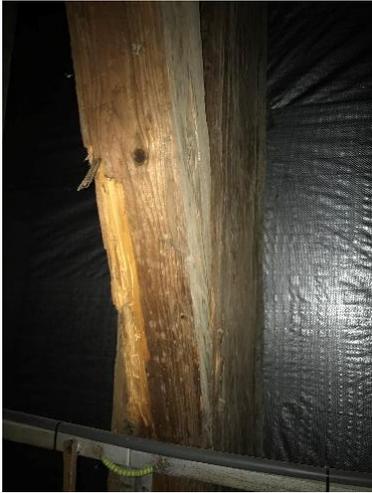
<p>Surface crack</p>	<p>Mass loss of the wooden material, 3-4 cm peeling along the element</p>	<p>Wood ageing and load bearing combined with MC change</p>

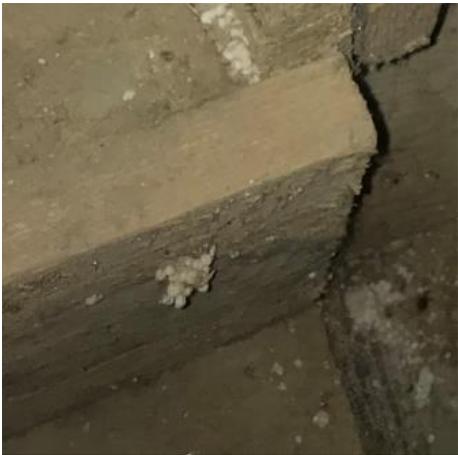
<p>Struts ends and posts ends.</p>
<p>Fungal Growth</p>	<p>Fungi growth on the wooden surface</p>	<p>Climate conditions and high MC</p>

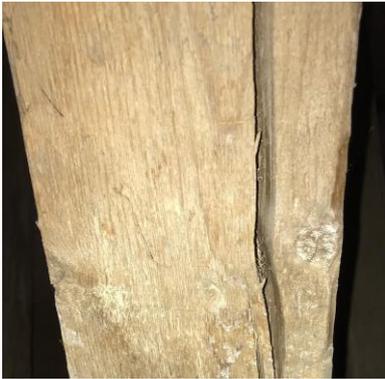
<p>Tie beams and posts</p>
<p>Longitudinal cracks</p>	<p>Cracks spread along the element ranging between 2 and 30 cm</p>	<p>Structural loads and site conditions</p>

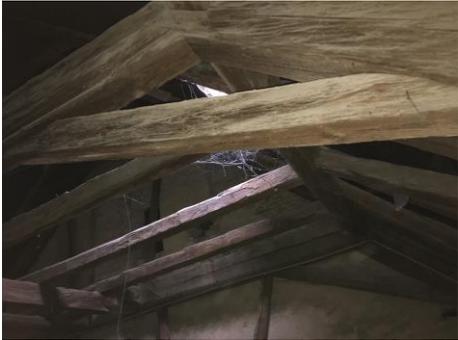
<p>All structural element types</p>
<p>Discolouring</p>	<p>Elements lose their original colour to become more faded</p>	<p>High M.C</p>

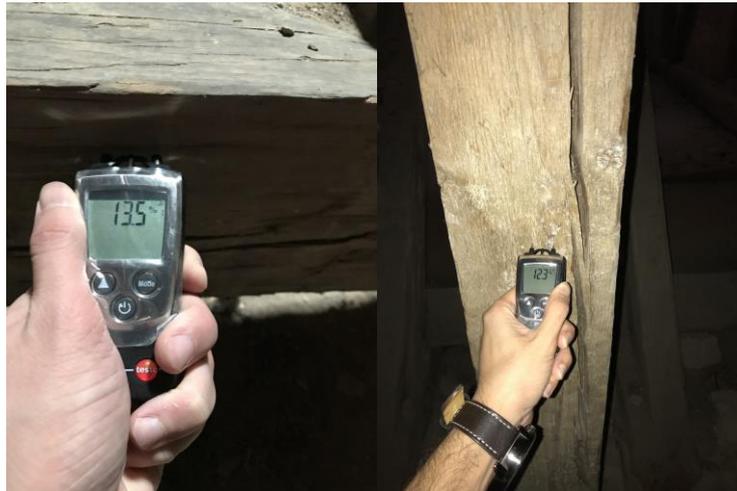
Figure 20. Moisture content measurements in the timber elements of the roof

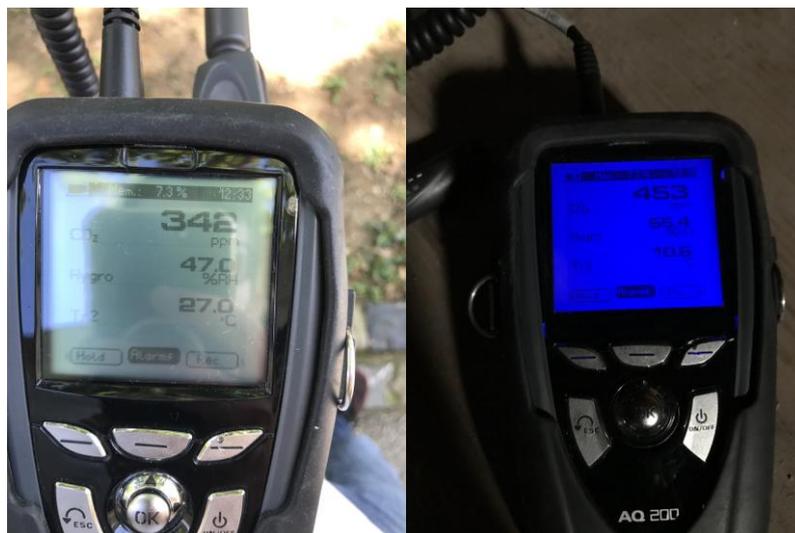
Figure 21. Devices for the outdoor and indoor measurements of temperature and relative humidity

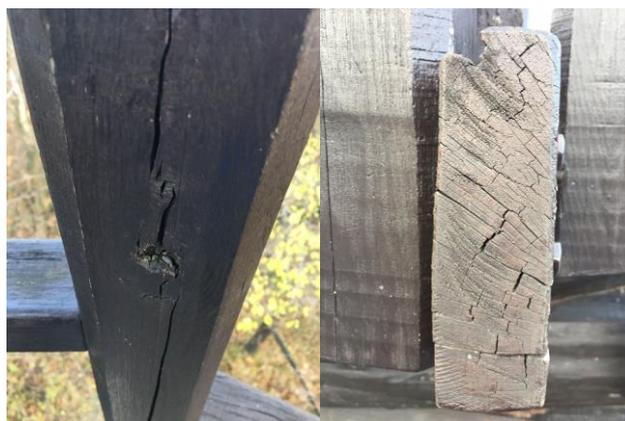
The visual inspection reveals the tower to be in excellent condition. The stairs have a thickness of approximately 25 cm, with a width ranging from 20 to 30 cm and a length varying between 90 and 105 cm. Due to the helix form of the stairs, the column cross-section measures 12x12 cm². The wooden surface remains in good condition and vibrant colour, thanks to protective paint. However, it is worth noting that the colour begins to fade gradually from the centre towards the fence, a consequence of exposure to sunlight. Cracks are evident in various locations on the tower, attributed to environmental factors such as rain and wind, as well as the live load from people moving about (see Figure 33).

Figure 33. Cracks in the Makovecz Imre lookout tower [own photo]

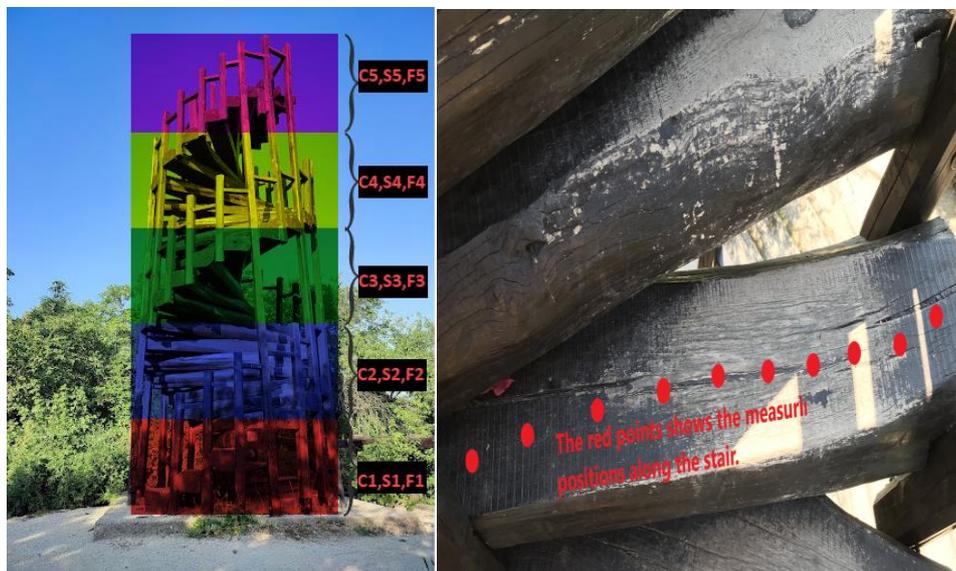
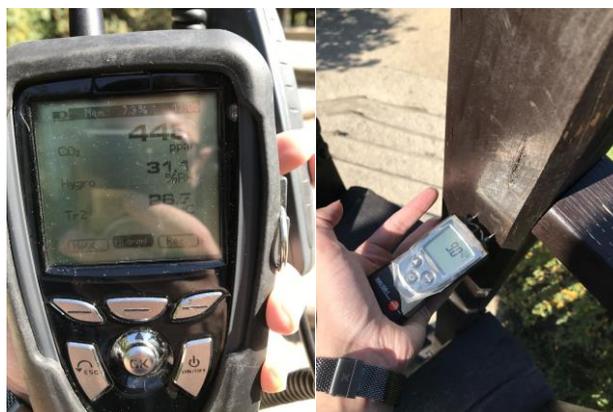
In this stage I measured T, RH, and MC for the wooden elements of the tower. The measurements were conducted over four seasons through weekly visits to comprehensively assess and monitor the condition of the timber elements of the tower throughout the year. The measurements started on July 10, 2021, and finished on April 29, 2022. The measurement procedure involved striking each wooden element at 10 different spots along its length and recording the average values. The primary elements measured were the columns (designated as C), stairs (designated as S), and fences (designated as F). The tower was segmented into five elevations, progressing from the top to the bottom. Columns in elevation 1 were denoted as C1, and a similar process was applied to the other parts. The process is illustrated in Figure 34 and Figure 35.

Figure 34. On-site measurement process in the Makovecz Imre lookout tower [own photo]

Figure 35. On-site measurements on the timber elements of the tower [own photo]

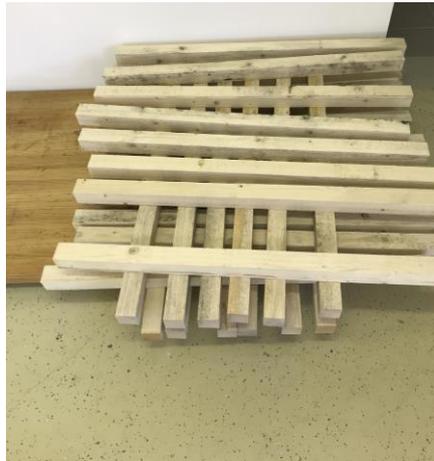
The average mechanical properties for the samples were 52.29 MPa for MOR, 11.2 GPa for MOE, with an average density of 366 kg/m³. Following the cutting process, the samples were categorized into groups A, B and C. Group A comprised samples tested under natural conditions (room T at 23.8 °C and RH at 29.3 %). Group B consisted of samples submerged in water (pH 6.5, total hardness 50 CaO mg/l) for 7 days until reaching a fully saturated state, while group C underwent testing under the same conditions as group B but was coated with a protective material before submersion. The protective material used, Sadolin Extra, is a commercially available outdoor silk-gloss thick glaze designed to protect and decorate outdoor wooden surfaces. According to the manufacturer, it offers long-lasting protection against weather and UV radiation from the sun. Additionally, it has a water-repellent effect and is absorbed by the wood.

Figure 44. Group A samples [own photo]

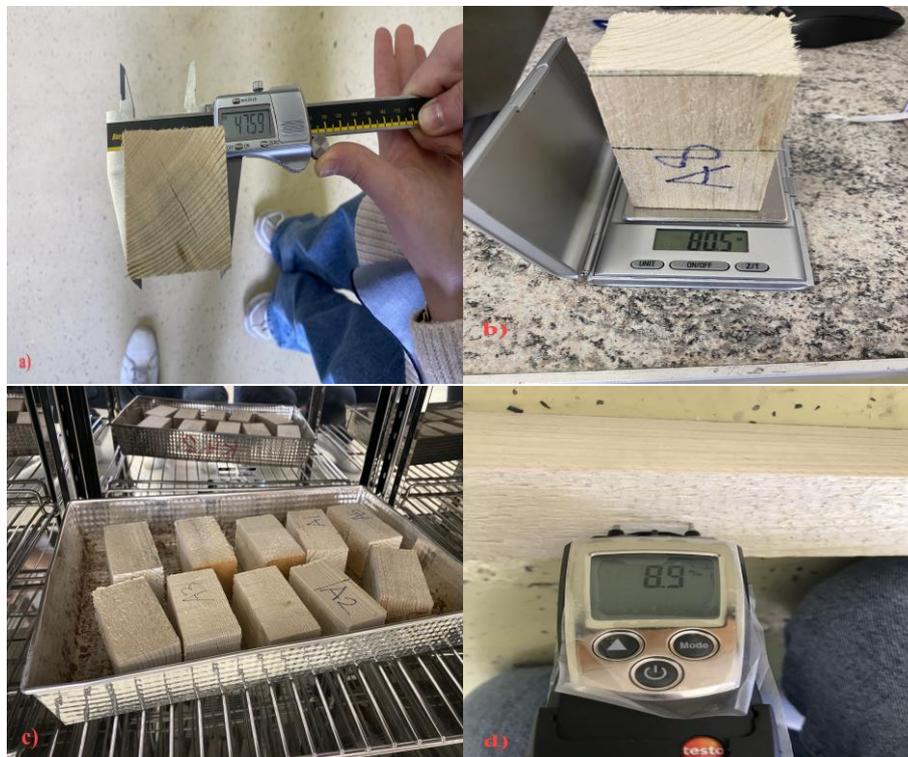
Figure 51. a) geometry measurements b) weight measurements c) drying samples d) surface MC measurement

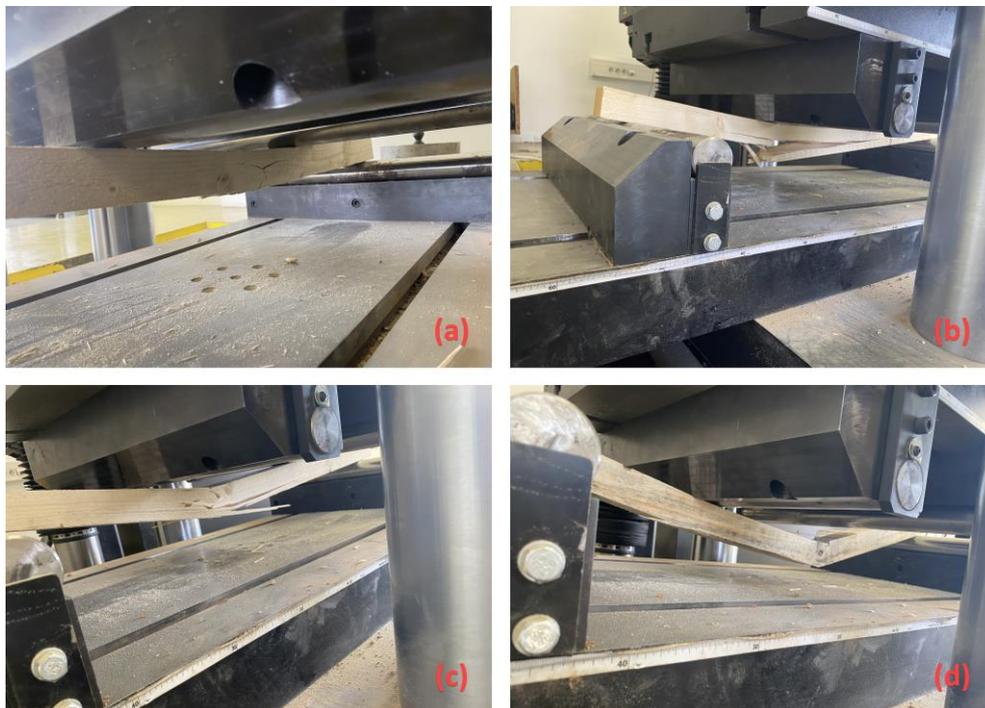
Figure 52. Failure modes found during the test for the case of group A, a) simple tension failure; b) cross-grained tension failure; c) brash tension failure; d) buckling failure

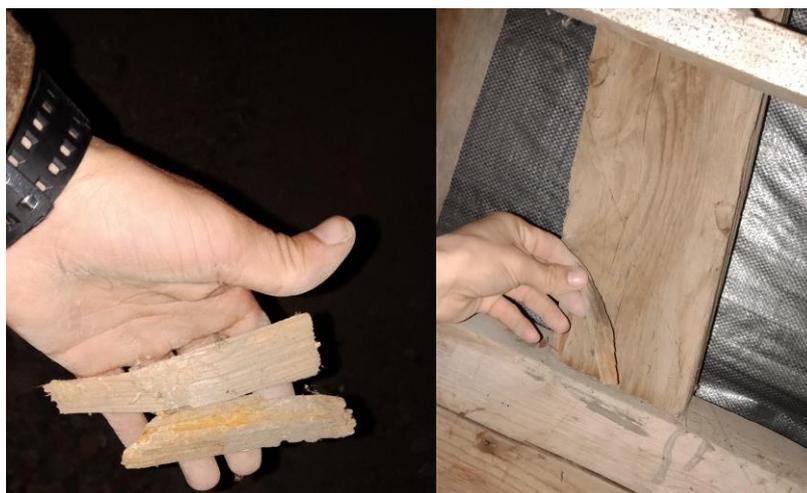
Figure 62. Collected samples for SEM
